Case History

Analysis of generator rotor unbalance

by *George Murray and John Mucci*
Consolidated Edison
and *Scott Brier*
Sales Engineer
Bently Nevada Corporation

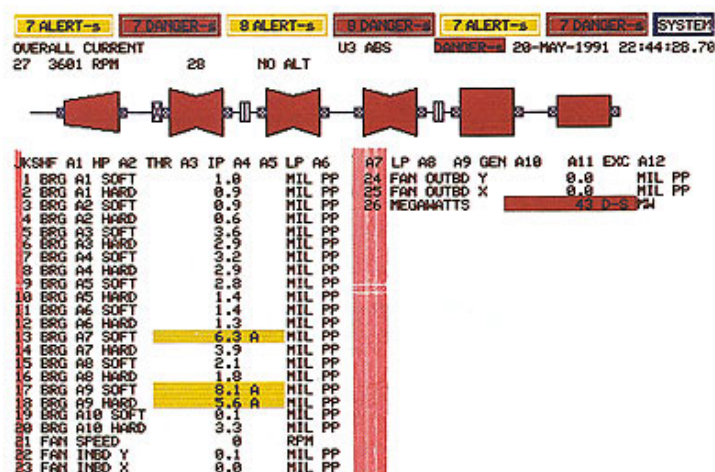
Figure 2
High vibration levels on Bearings No. 7 & 9 detected on System 64
Current Overall Values screen

On May 20, 1991, shortly after Unit No. 3 returned to service, the vibration monitor's alarm status went into a "Danger" condition. The overall vibration levels shown in Figure 2, indicate that Bearing No. 9 was experiencing high vibration. When they viewed the synchronous or 1X frequency component (Figure 3), operators noticed that this was the major contributor to the overall vibration. They decided to install an unbalance correction weight (balance shot) in the generator rotor as an attempt to reduce its 1X vibration.

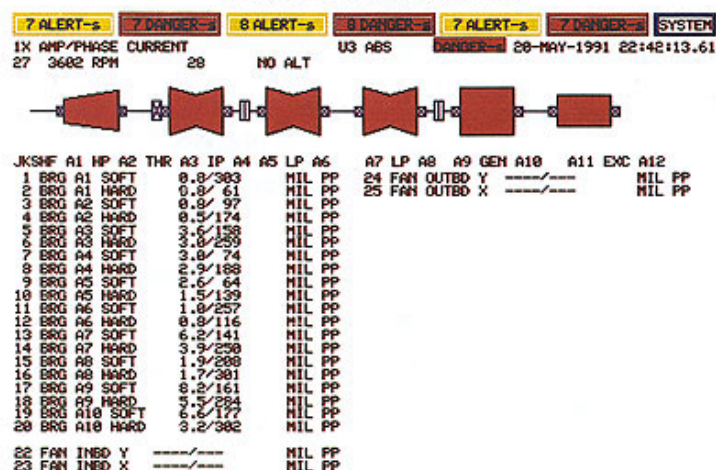
Figure 3
System 64 Amplitude versus Phase screen

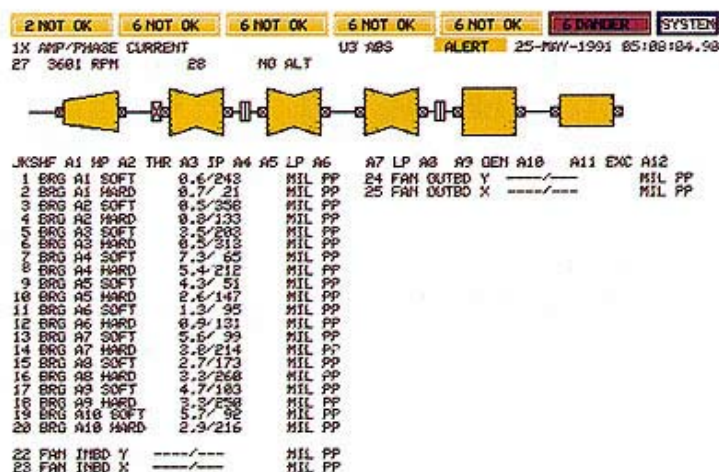
A balance shot was calculated, and correction weights were installed in the generator rotor on May 23. Figure 4 shows that, while the balance move brought Bearing No. 9's 1X vibration below the alarm levels, Bearing No. 10 was now in an Alert condition. Another balance shot, to trim the vibration down to a more acceptable level, was installed on May 26. This balance shot behaved as expected, and all parties felt that further balancing would have a beneficial effect on the unit's overall vibration levels.

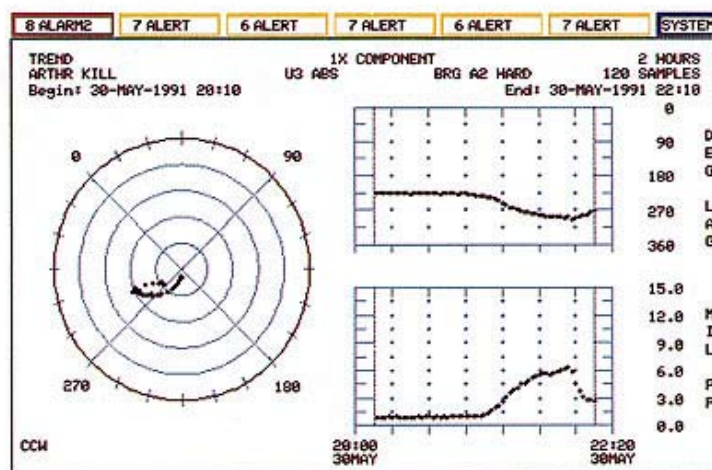
Figures 5 and 6 are 1X Amplitude/Phase Trend plots for the turbine and generator, respectively. From these figures, it was concluded that the generator Bearing No. 10 (Figure 6) was responding to a turbine steam seal rub (Figure 5) and not rotor unbalance. These plots show how the 1X vector "walked out," reversed direction, and then returned to its original position. This is an example of how a steam seal rub initiates and finally rubs itself out.

Figure 5
1X Amplitude/Phase Trend plot of the turbine

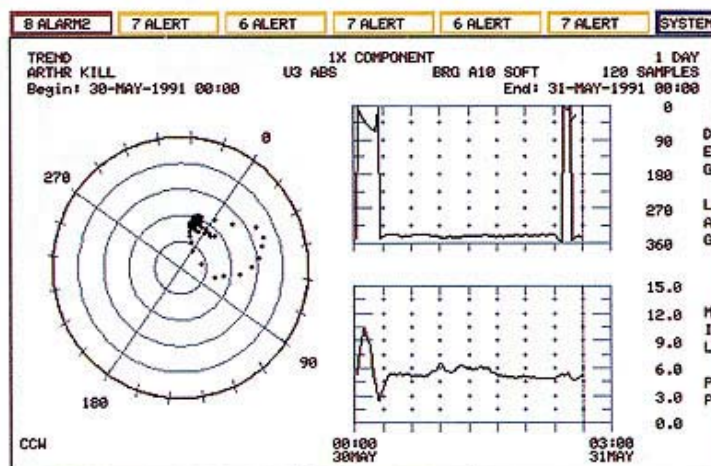
Figure 6
1X Amplitude/Phase Trend plot of the generator

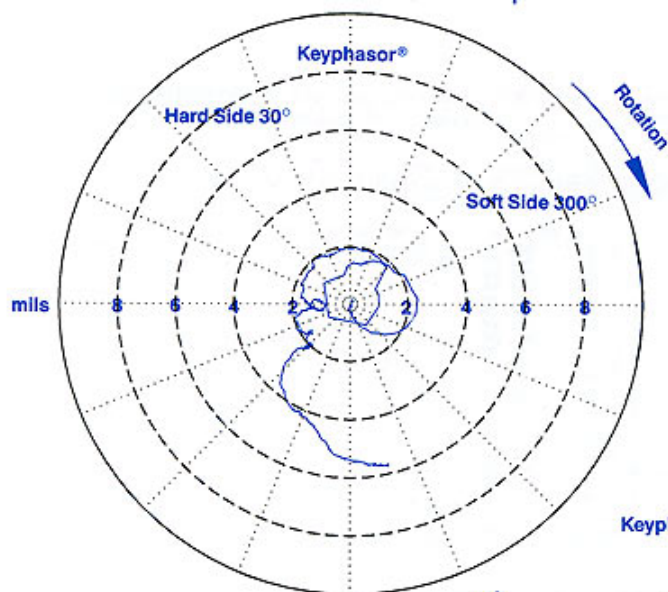
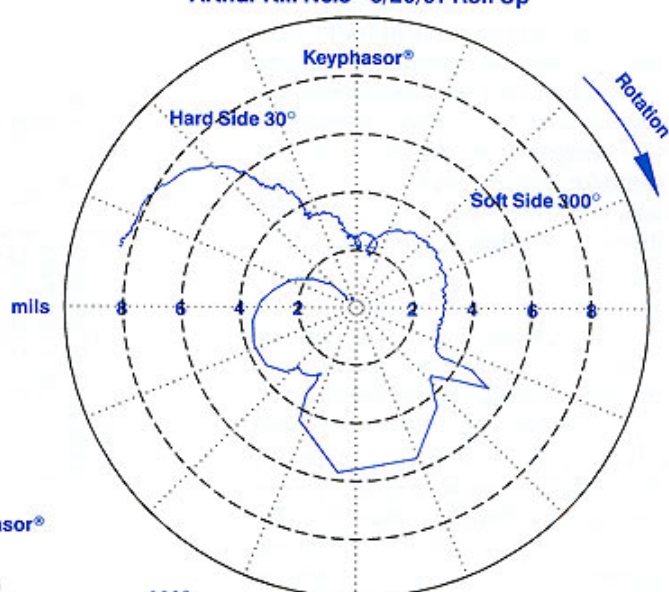
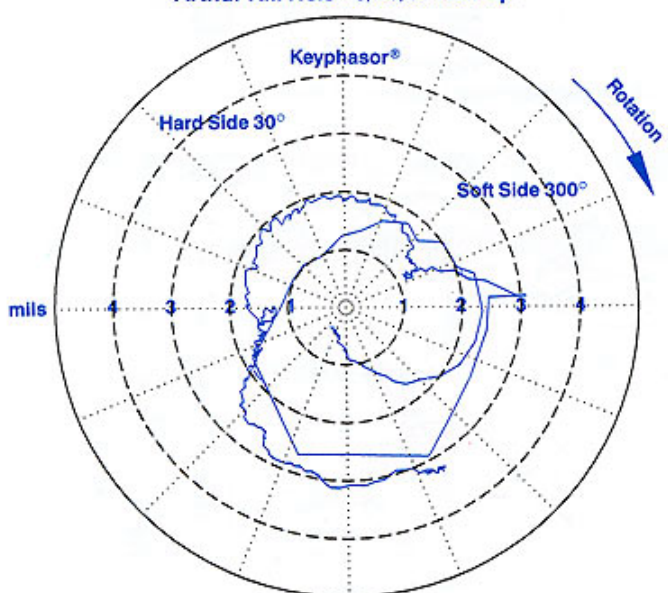
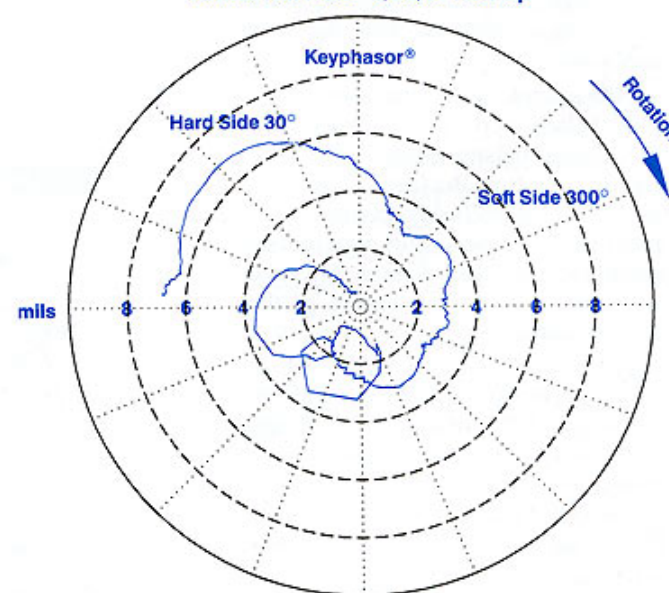
Because the generator was operating close to its third balance resonance speed (Figure 7), any additional excitation, even down at Bearing No. 2, would result in an amplified response. That is why Bearing No. 10 had a greater

Figure 7
Polar plots of Machine Startup. Note: Third party software was used.

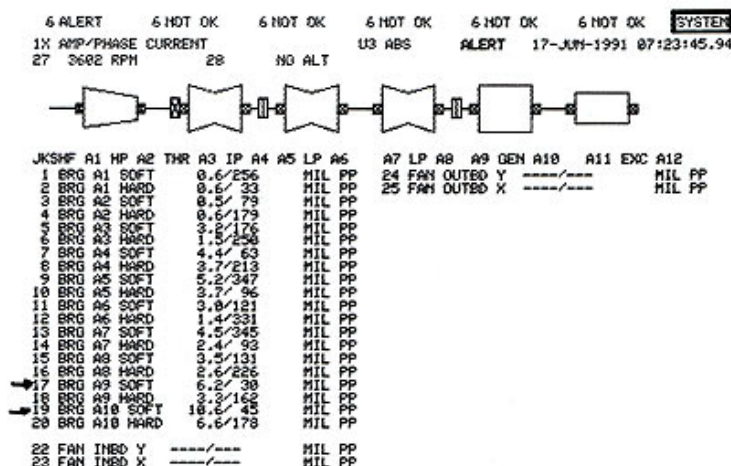
Figure 8

After working out the rub, the unit operated relatively trouble-free. On June 17, an overspeed trip test was scheduled for Unit No. 3. Because the generator rotor had responded favorably to previous balancing attempts, another balance shot was attempted by placing the correction weight in the alterex-to-generator coupling at a radius of 8 inches (203 mm). For a relatively small correction weight (5 ounces or 142 grams) at the alterex coupling, the results were totally unexpected. Generator vibration increased to levels that were not consistent with either the correction weight mass or previous responses (Figure 8).

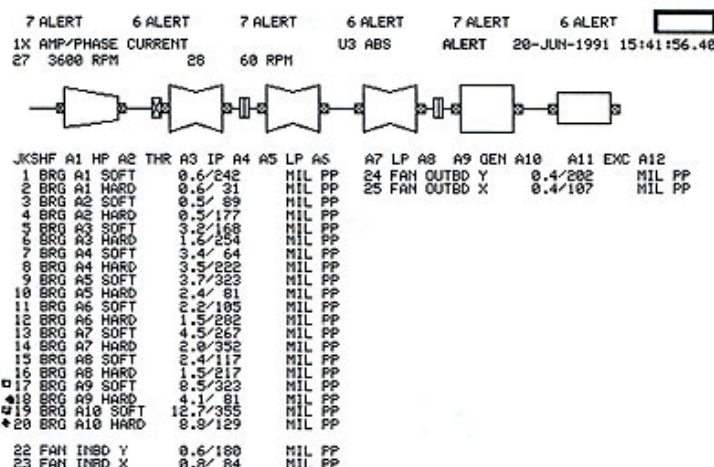
Figure 9

This immediately alerted the station's operating personnel to a potential problem with the generator. However, it was decided to attempt another balance shot on June 20 to verify the inconsistent results. The results once again were inconsistent with the expected response (Figure 9). The decision to continue balancing was aided by having the unit's operating conditions continuously monitored.

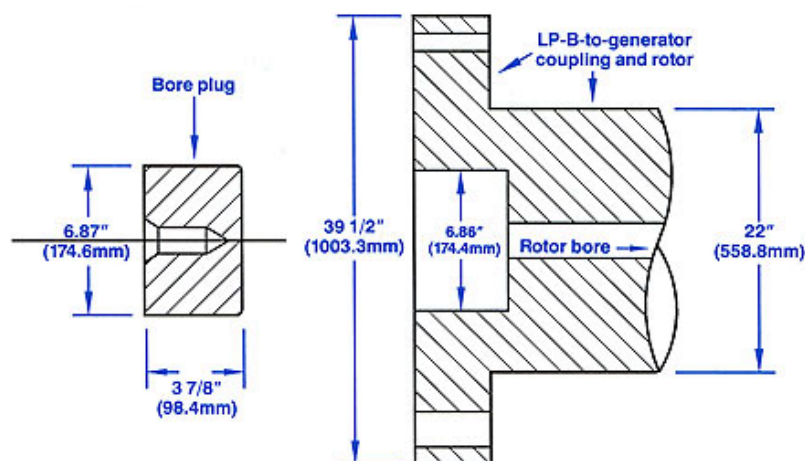
On September 23, 1991, the Low Pressure-to-Generator coupling was disassembled and parted. As predicted, the Low Pressure rotor's bore plug was found in the coupling spacer gear's bore. Figure 10 shows how the bore plug fits into the coupling bore.

Diagram showing how the bore plug fits into the coupling bore

The information from System 64 was critical in arriving at a correct diagnosis of this problem. When the bore plug was reinstalled, vibration levels returned to acceptable levels. This case history documents the importance of computerized monitoring systems used in conjunction with a traditional monitoring system. ■
